MTL TR 91-24

# EXAMINATION OF PROTECTIVE COATINGS UTILIZED ON ARMY DS2 CONTAINERS

VICTOR K. CHAMPAGNE, Jr., MARC S. PEPI,  
CATHERINE M. ZOLLER, and SAUL ISSEROW  
MATERIALS TESTING AND EVALUATION BRANCH

June 1991

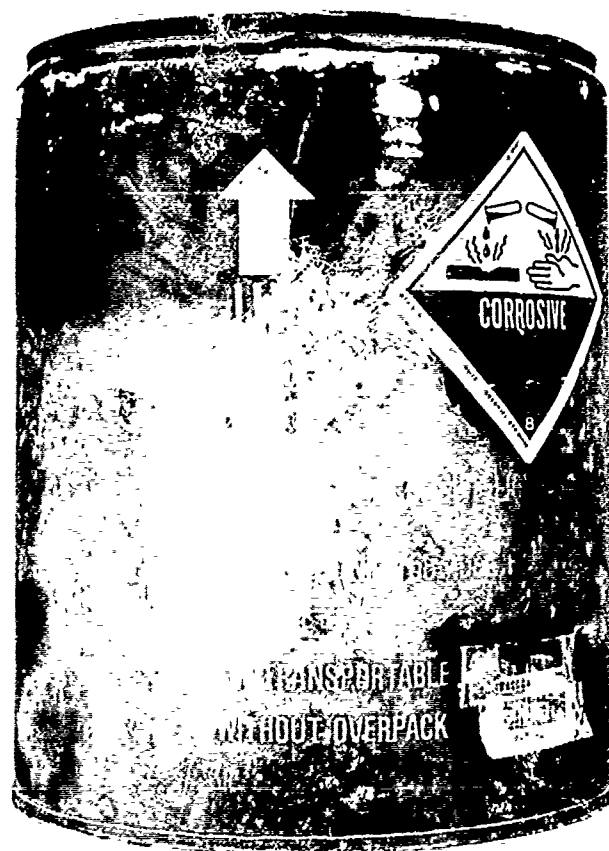
Figure 1 shows the five-gallon container in the as-received condition. Overall, this container showed the least amount of corrosion when compared to the other two containers. Near the top, large areas of the green topcoat had been chipped away, as a result of mechanical

Figure 1. Five-gallon container in the as-received condition. Reduced 70%

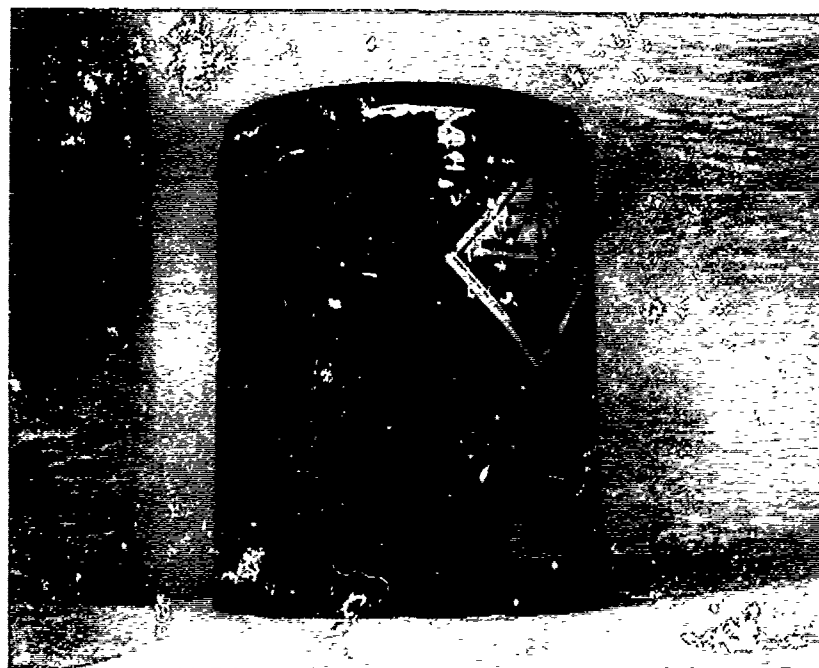
damage, leaving behind a bright white undercoat, as depicted in Figures 2 and 3. In addition, all three macrographs reveal a dull, matte finish on approximately 66% of the surface area of the container. This was most likely the result of weathering and exposure to adverse storage conditions. Figure 4 illustrates an area near the bottom weld chime where the topcoat had also been damaged. To the left of this region, a few isolated blisters and corrosion of the base metal occurred. The only significant evidence of corrosion was observed at welded seams which trapped moisture and allowed crevice corrosion to take place. Figure 5 shows the bottom weld chime which contains an example of crevice corrosion at the welded seam (top of micrograph). The bottom edge of the container had experienced some general corrosion where the external surface coating had been worn away. Figure 6 represents the corrosion observed along the side weld seam which also served as a site for water entrapment.

Figure 2. Prior mechanical damage to five-gallon container revealing bright white undercoat. Reduced 85%

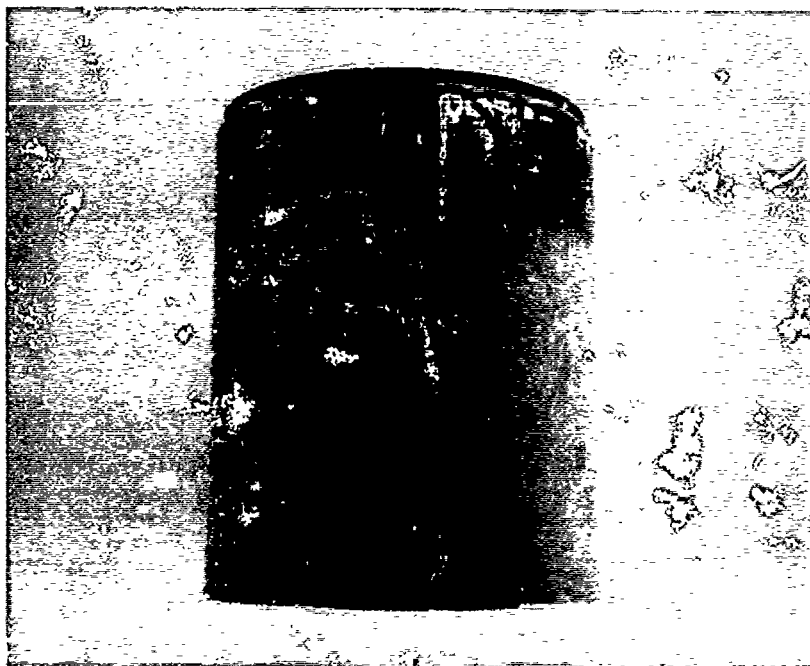
Figure 3. Another view of prior mechanical damage to five-gallon container revealing bright white undercoat. Reduced 85%

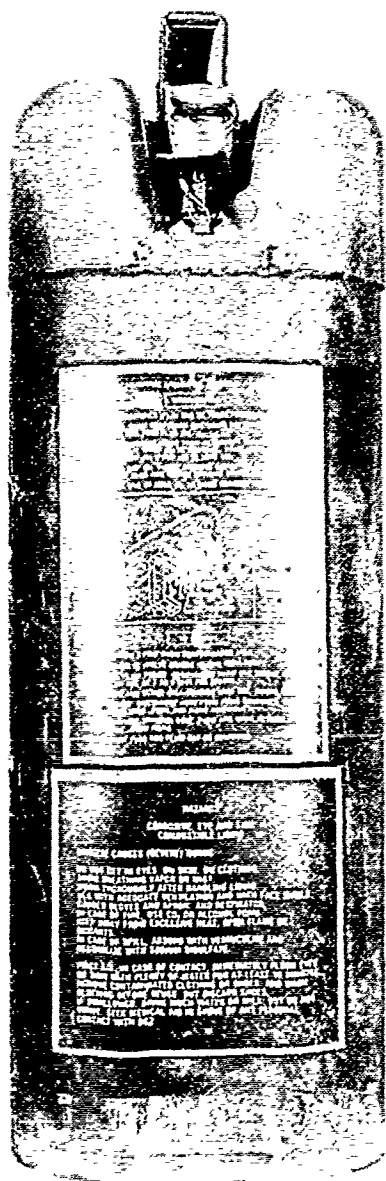
Figure 7. 14-liter container in the as-received condition.

Figures 7a and 7b show the 14-liter container in the as-received condition. This container consisted of various welded parts at the top and consequently numerous areas of corrosion were observed. On the top, general corrosion was prevalent on regions along the rounded surface, as shown in Figure 8. The protective coatings on these surfaces could easily be damaged during handling, exposing bare metal to the environment. Crevice corrosion occurred on both latches at regions which are welded to the container and support the handle. These latches did not have a continuous weld and consequently contained crevices where moisture could collect and cause corrosion, as revealed in Figures 9a and 9b. Corrosion was also noticed where the top containment latch came into contact with the surface of the container. General corrosion was observed on the handle itself, (refer to Figure 10) as its concave design allowed water to puddle. In addition, general corrosion occurred on the base of the container where it came in contact with the ground or another support, as Figure 11 illustrates. Here, the coating appeared to have been lifted away exposing the base metal. Overall, some of the design features of this container were conducive to corrosion.

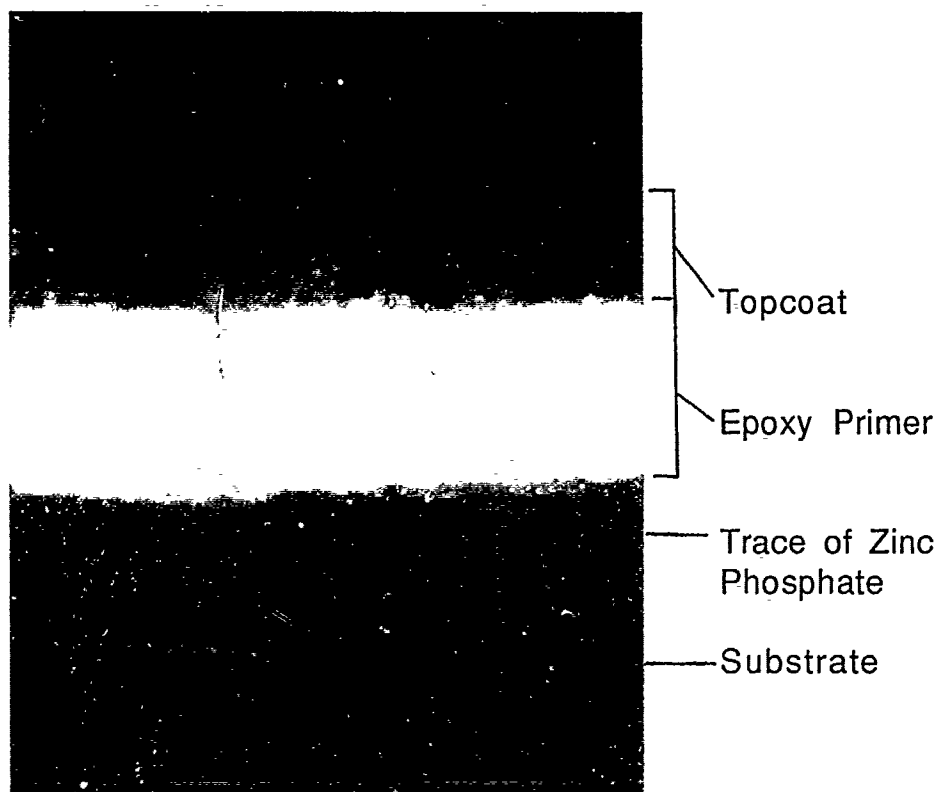
Figure 19 shows a representative cross section of the coating system of the five-gallon container taken from the side weld. This optical micrograph was exposed under polarized light in order to highlight the different coating layers.

In general, the coatings displayed good adherence and were uniform, except for the phosphate layer which appeared to be quite discontinuous. Figure 20 further illustrates this point as it shows a thick phosphate layer, in contrast to Figure 19 which revealed only trace

Figure 19. Representative cross section of the coating system of the five-gallon container taken from the side weld area. Mag. 500X

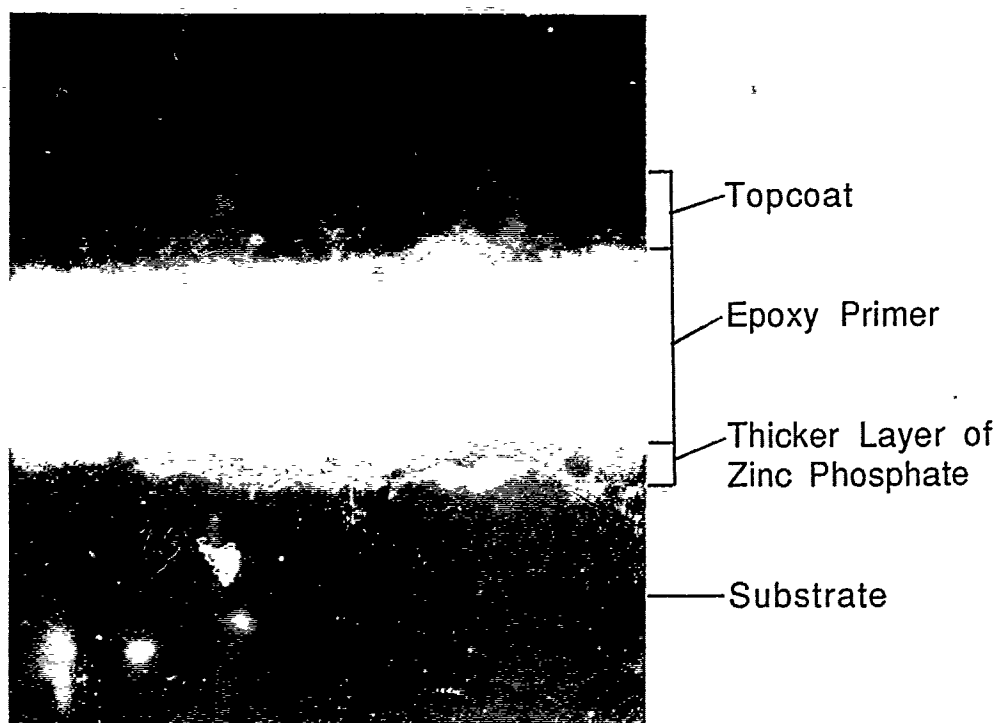
amounts of this coating. Figure 20 represents an area sectioned from the side weld where the topcoat was nonuniform and thinner than the specification permitted. Figure 21 shows a cross section of the top weld which did not contain a topcoat layer. As previously described, within the Visual Inspection section of this report, areas of the topcoat had been damaged contributing to the nonuniformity of the topcoat. Regions where the closure contacted the top of the container were especially susceptible to this type of damage.

Figure 20. Representative cross section of the coating system of the five-gallon container taken from the side weld area, showing a thicker zinc phosphate coating. Mag. 500X

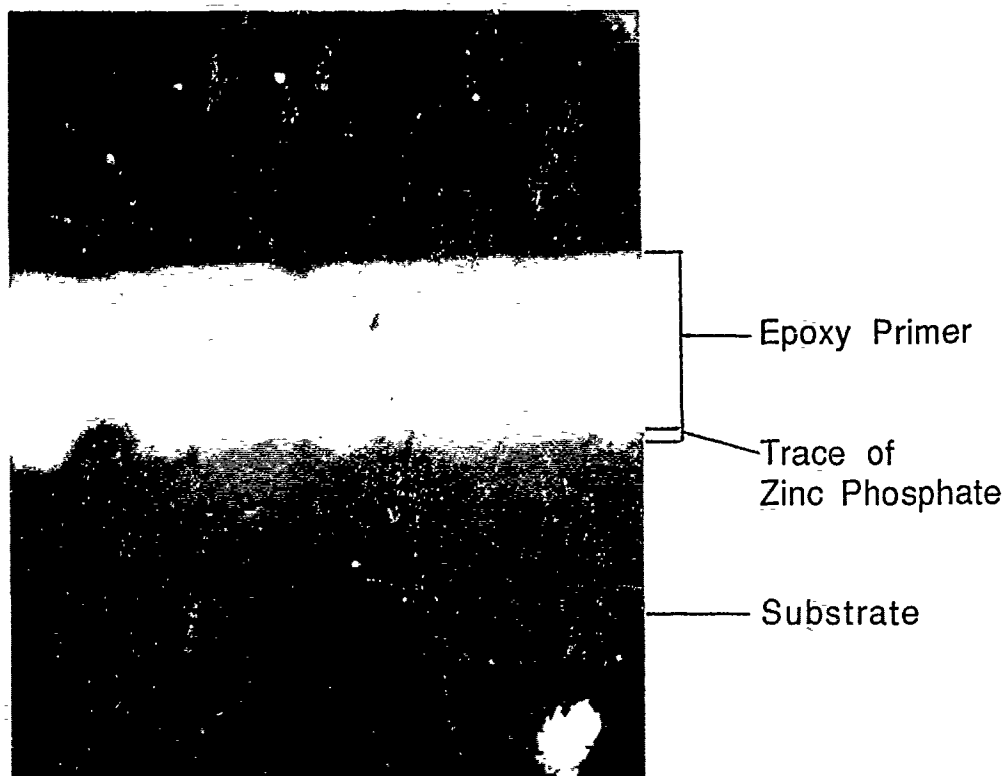
Figure 21. Cross section of the top weld of the five-gallon container indicating the nonexistence of a topcoat layer. Mag. 500X

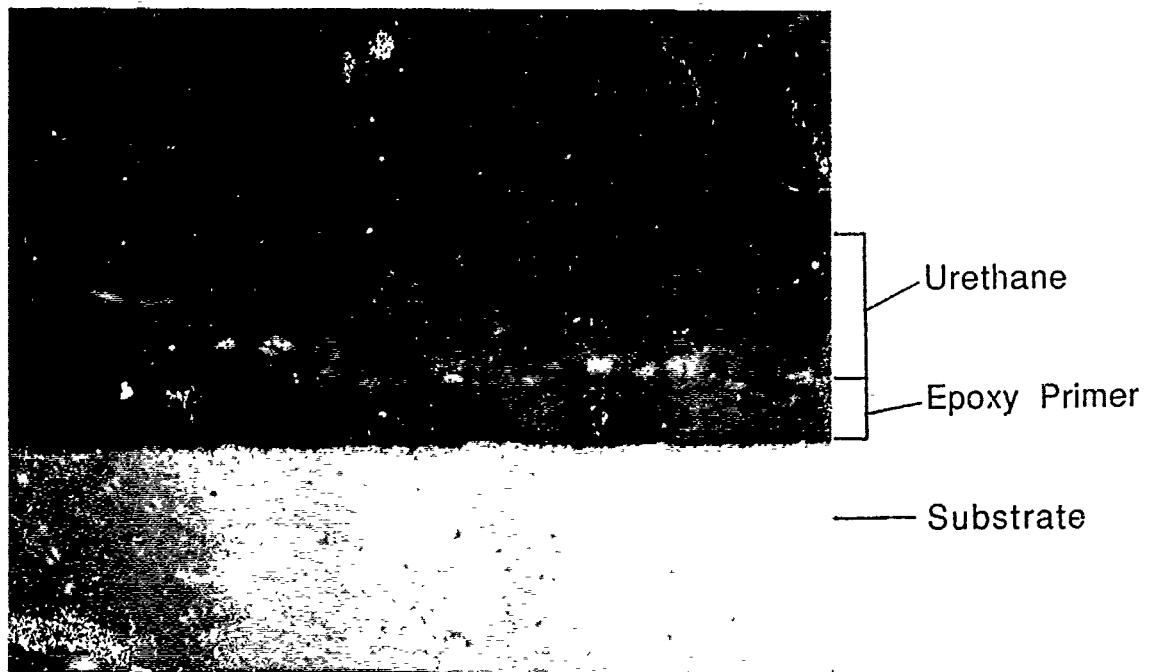
Figure 25 shows a representative cross section of the coating system of the 14-liter container taken from Side B. The use of polarized light was effective in distinguishing the various coating layers. The wash primer was best examined utilizing electron microscopy since it was only about 0.0002 inches in thickness and required analysis at higher magnification. It appears as a fine dark line in the photograph. The epoxy primer layer is red in appearance while the urethane topcoat is green.

In Figure 25 the epoxy primer is approximately 0.6 mils in thickness while the topcoat averages about 1.8 mils which conformed to the lower range of the specified requirements. This trend was observed throughout most of the specimens examined. The urethane coating was also nonuniform at the top and bottom of the container and the epoxy primer was very discontinuous in these same areas, as Figure 26 reveals. The epoxy primer appeared spotty beneath the green topcoat instead of as a continuous layer. The photograph clearly shows the green urethane coating in intimate contact with the wash primer on the substrate and the absence of a red epoxy primer coating on most of the specimen.

Figure 25. Representative cross section of the coating system of the 14-liter container taken from side B. Mag. 500X

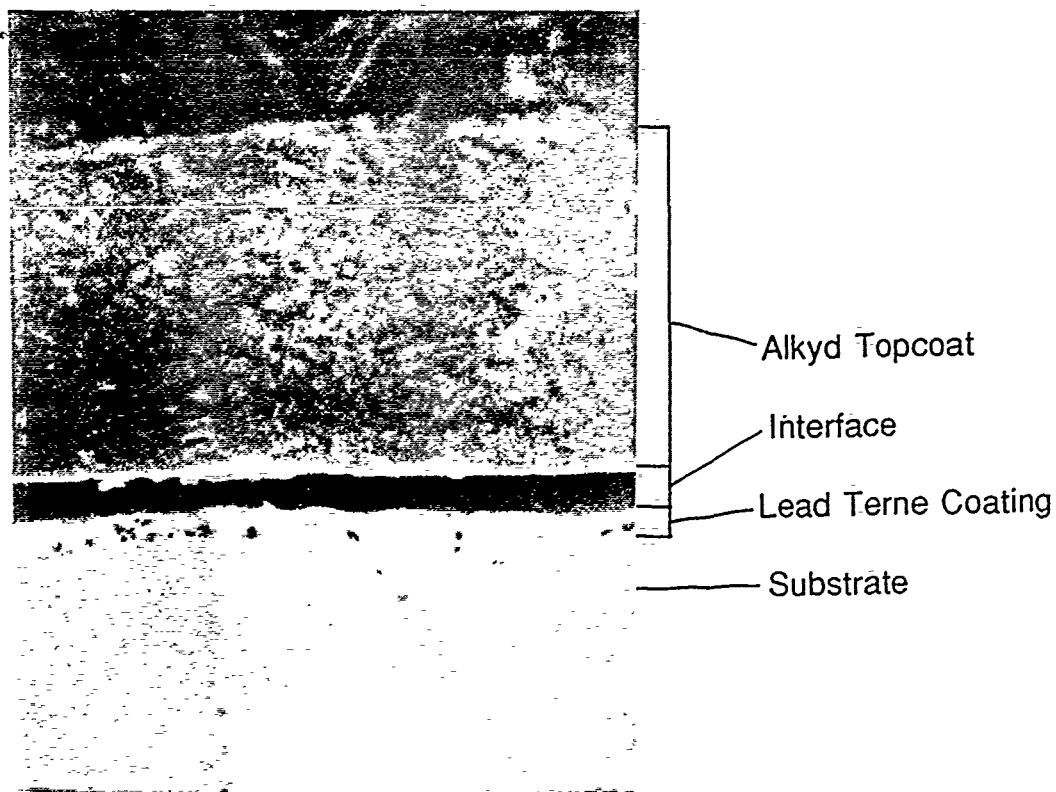
Figure 44 is an SEM micrograph of the exterior coatings located on the top weld of the 1-1/3-quart container. The black region separating the alkyd coating from the terne coating is an interface where there is no adhesion. The photograph identifies the terne coating and the alkyd topcoat. Figure 45 shows the interior terne coating observed on the top weld cross section. Both interior and exterior terne coatings were uniform and displayed good adhesion to the steel substrate. Figures 46 and 47 reveal the resulting spectrum obtained from the exterior and interior terne coating, respectively. The only major peaks detected consisted of lead and tin which are the primary elemental constituents of the coating. Figure 48 is the resulting spectrum of the alkyd coating present on the 1-1/3-quart container. Figure 49 represents the infrared spectrum of the same coating which indicates that the coating was an alkyd.

Figure 44. SEM micrograph of exterior coatings present on the 1-1/3 container. Mag. 750X
